Federal Creosote Superfund Site Rustic Mall Final Remedial Action Report

June 2008

REMEDIAL ACTION REPORT

**OU3 - RUSTIC MALL REMEDIAL ACTION
FEDERAL CREOSOTE SUPERFUND SITE
MANVILLE, NEW JERSEY**

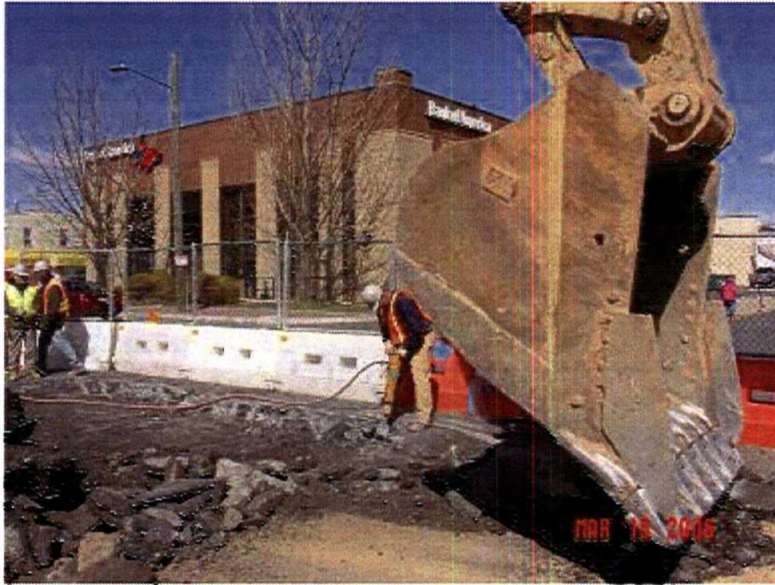
Photo 3-1 – Pavement Removal

Demolition of the Rustic Mall building that contained the supermarket and other businesses was conducted by the Rustic Mall property owners during the course of remedial construction. The demolition and removal of above-ground portions of the building was completed entirely without EPA involvement. Once the building was demolished to the slab, foundation and slab removal was conducted by SES as excavation progressed.

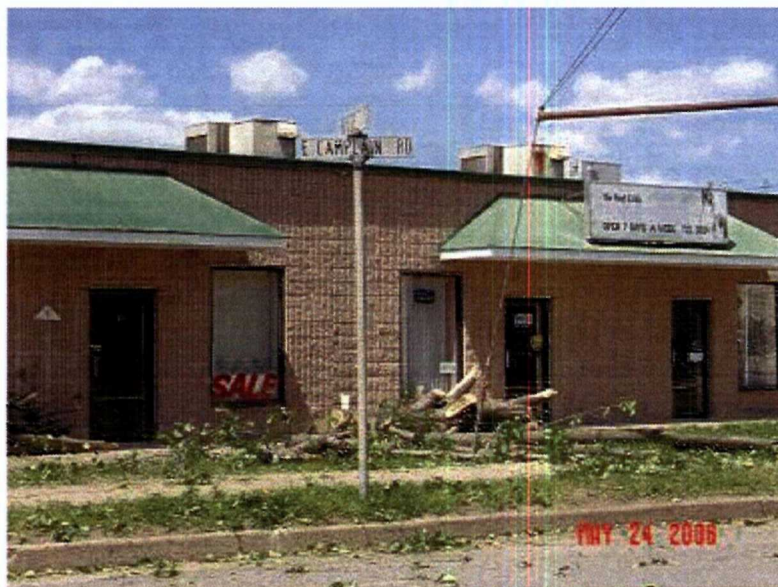
Photo 3-2 – Site Clearing

Clearing and grubbing of the South Area was conducted as needed for the remedial construction. Stumps from grubbing operations were decontaminated and disposed of as construction and demolition debris.

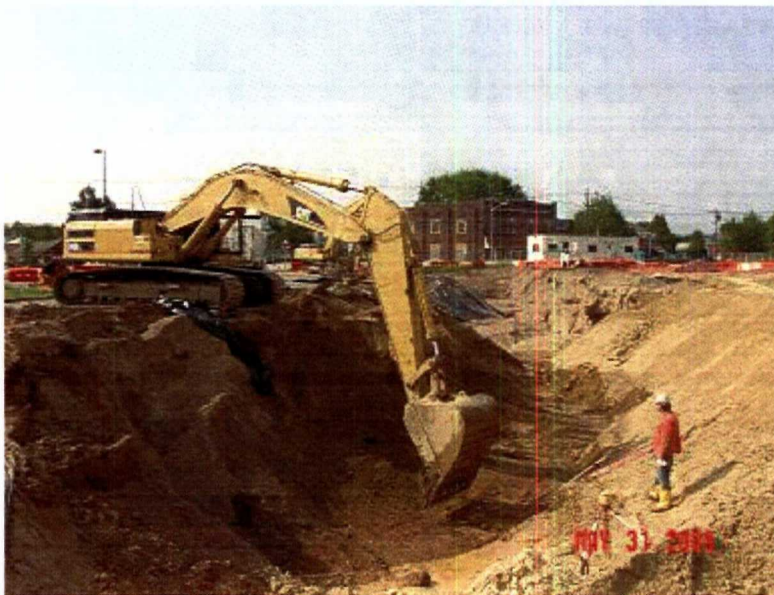
Photo 3-3 – Excavation Operations

The excavation was organized into four areas: South, Southwest, and two North Areas (North Area 1 and North Area 2). SES excavated to the limits in the South, Southwest, and North Areas of the Rustic Mall as shown on the contract drawings. Upon completion of excavations, SES inspected both the sidewall and the bottom of the excavated areas for visible sign of contamination. If contamination was suspected, the Contracting Officer was notified and SES proceeded as directed. A total of 177,844.08 of soil was excavated and transported off site for disposal.

Excavation was completed in phases throughout the Rustic Mall in order to minimize the impact to the businesses that were operating at the time. The sequence was as follows; Southwest Area, North Area 1 (Support Zone), North Area 2, South Area. At the beginning of excavation in North Area 2, the building demolition was uncertain, therefore the original limits of excavation were such that the building could remain if the owners didn't demolish it. Excavation limits in North Area 2 and the South Area were changed during the design as the building footprint became available for investigation and design.

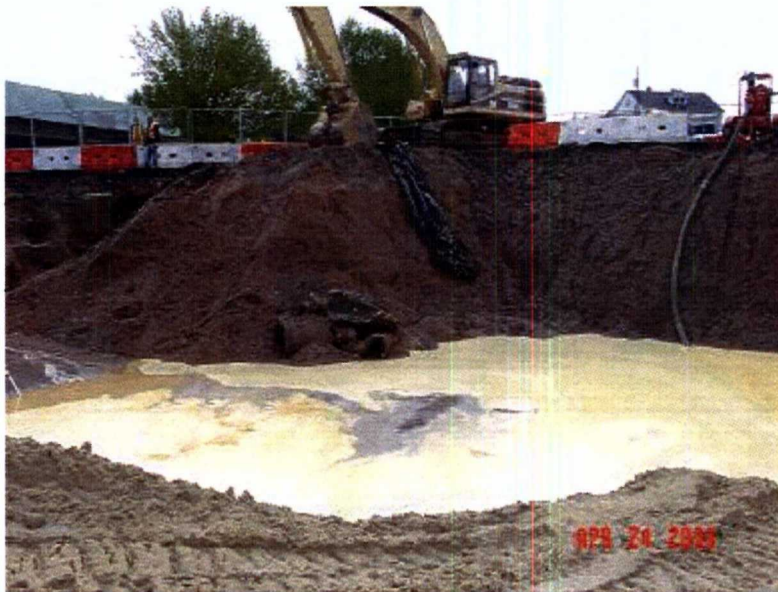
Photo 3-5 - Dewatering

Perimeter dewatering system was not necessary during the Rustic Mall remediation since the excavations were relatively shallow. Perched water encountered during the excavation as well as surface runoff that accumulated within the excavation areas was pumped out as needed and treated at the on-site wastewater treatment plant prior to discharge.

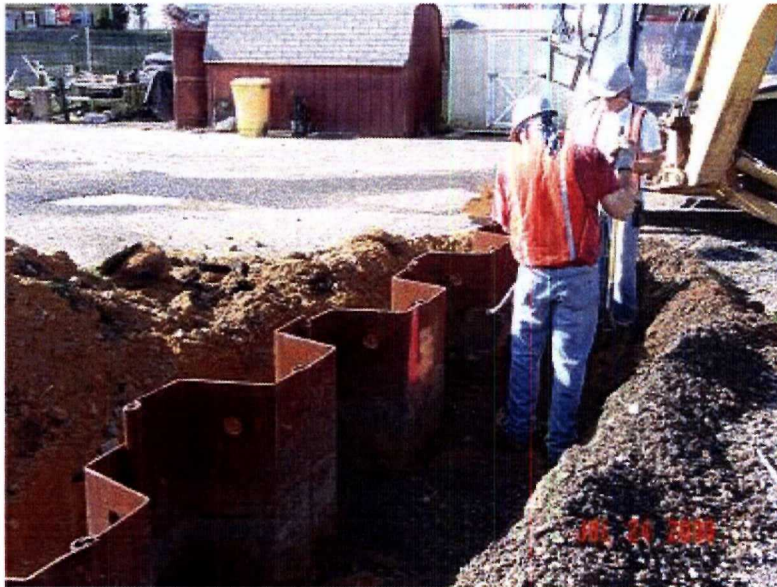
Photo 3-6 – Excavation Support System (Sheeting)

construction. However, the existing soldier piles installed during the Lagoon A remediation were reused as a support system for the adjacent Rustic Mall excavation. Re-use of the existing soldier piles required installation of lagging, walers, and tiebacks during the Rustic Mall excavation. All sheeting, soldier pile and lagging were installed by Linde-Griffith Construction Co., of Newark, NJ. An ICE 4500 vibratory hammer rigged to a Manitowoc 3000W 65-ton crane and a Bower BG18 drill rig was utilized to install the sheeting and soldier piles respectively. The tiebacks were installed by using a Clem drill rig. The soldier piles and sheeting were cut off four feet bgs and abandoned in place. Lagging and walers were removed, and tiebacks were abandoned in place. The locations of the sheet piles are shown on the as-built drawings included in Appendix C.

A 1:1 slope system was established for excavations deeper than four feet bgs. When excavation was directly adjacent to structures' foundations, a 1.5 horizontal to 1 vertical was established for excavations greater than ten feet bgs and a 1:1 slope system was established for excavations of ten feet bgs or less.

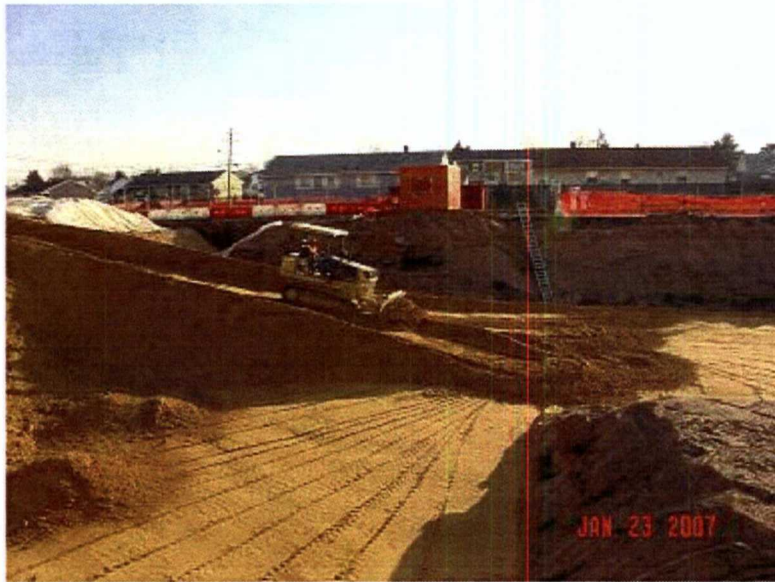
Photo 3-7 - Backfill Operations

SES backfilled the excavated areas using clean imported backfill material from several sources including Tomkat Construction, Inc., Stavola Construction Materials, Maddox Materials, LLC, and Excavating Material & Equipment, Inc. (EME). Prior to delivery to the site, physical and chemical analyses were performed on every 5,000 CY lot of material to ensure that backfill materials met the project requirements and specifications. All backfill material placed at the site met NJDEP residential direct contact cleanup criteria.

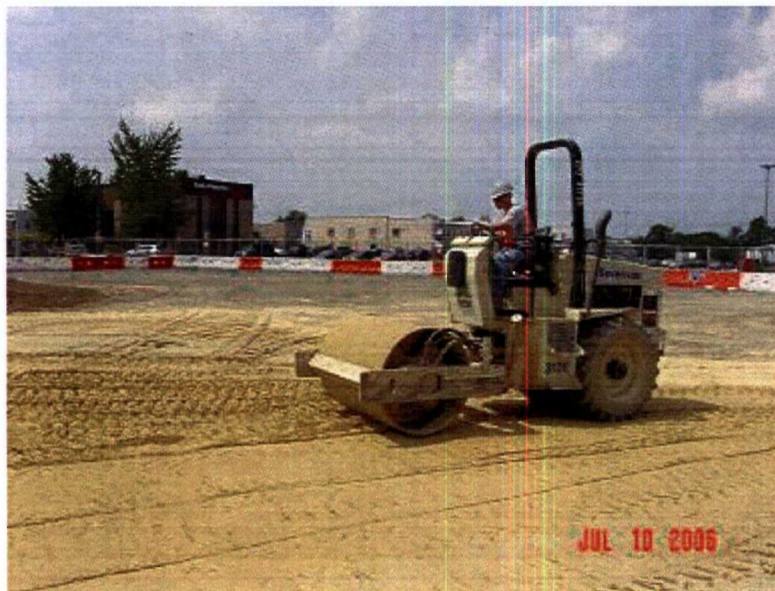
Photo 3-8 - Backfill Compaction Operations

(ASTM D-698). Hand compactors and/or vibratory plates were utilized to compact areas immediately adjacent to houses or other structures. Compaction and moisture content testing of the backfill material was performed by Craig Testing Laboratories, Inc. located in Mays Landing, New Jersey. Approximately 154,383.98 tons of common fill and 14,030.68 tons of Dense Graded Aggregate (DGA) were utilized to fill the OU3 excavation areas.

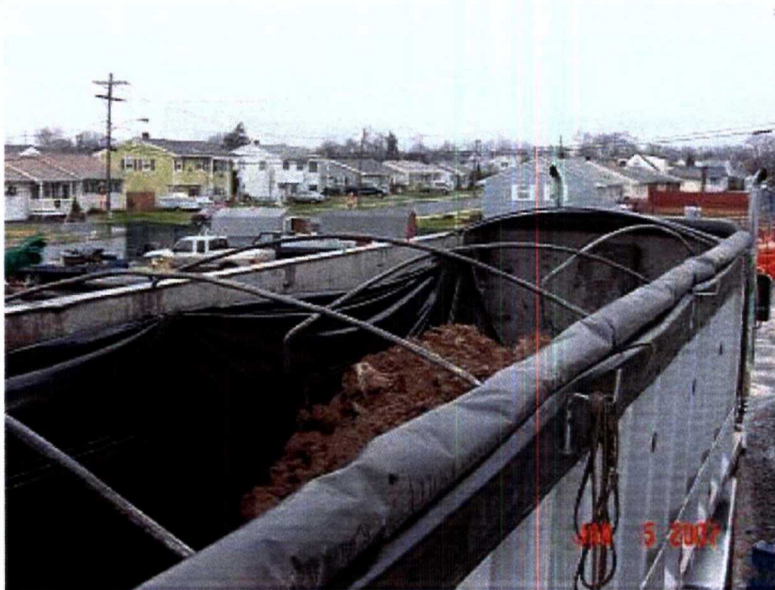
Photo 3-9 - Waste Hauler

Material to be disposed of at Subtitle C and D facilities were transported to their respective facilities by utilizing 70,000-lb triaxle dump trucks. Material requiring thermal treatment and disposal was loaded into 80,000-lb dump trailers for transportation to the thermal treatment facility. Trucks transporting excavated material to the facilities were required to be lined, tarped, and decontaminated (tire wash) prior to leaving the site.

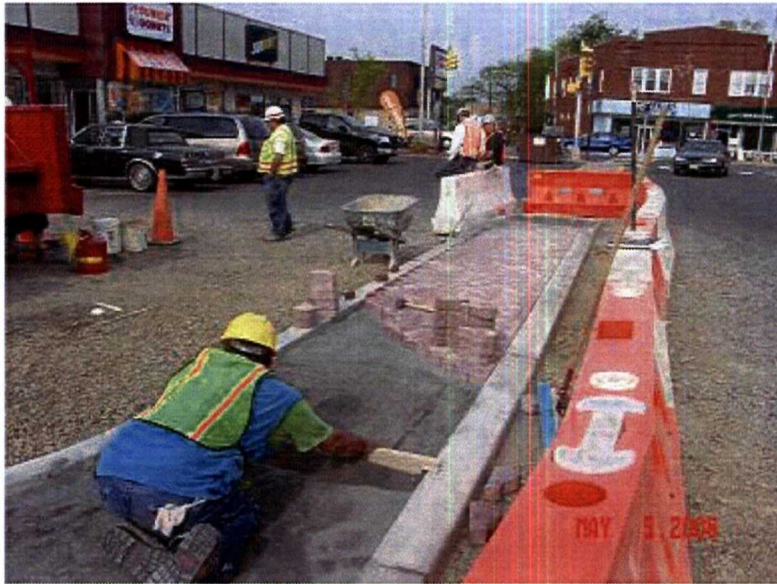
Photo 3-11 – Concrete Island Restoration

Property features impacted by construction activities were restored and/or replaced in kind by the contractor. Site restoration consisted of in kind replacement of items such as pavement, concrete slabs, curb, sidewalk, concrete traffic island, trees, bushes, shrubs,

fencing, inlets, and manholes that were disturbed or removed during construction as shown on the restoration plans included in the contract drawings. Utility service laterals impacted by the excavation were also restored. Utility work was performed by the respective utility companies or their authorized representatives, except for water, sanitary, and storm sewer work, which was performed by SES. The restoration plans also include restoring the area currently occupied by the Support Zone and WWTP. The asphalt pavement in the portion of this area that lies outside of the excavation limits was milled and repaved. Grading in this area has been altered to improve the drainage from the existing condition.

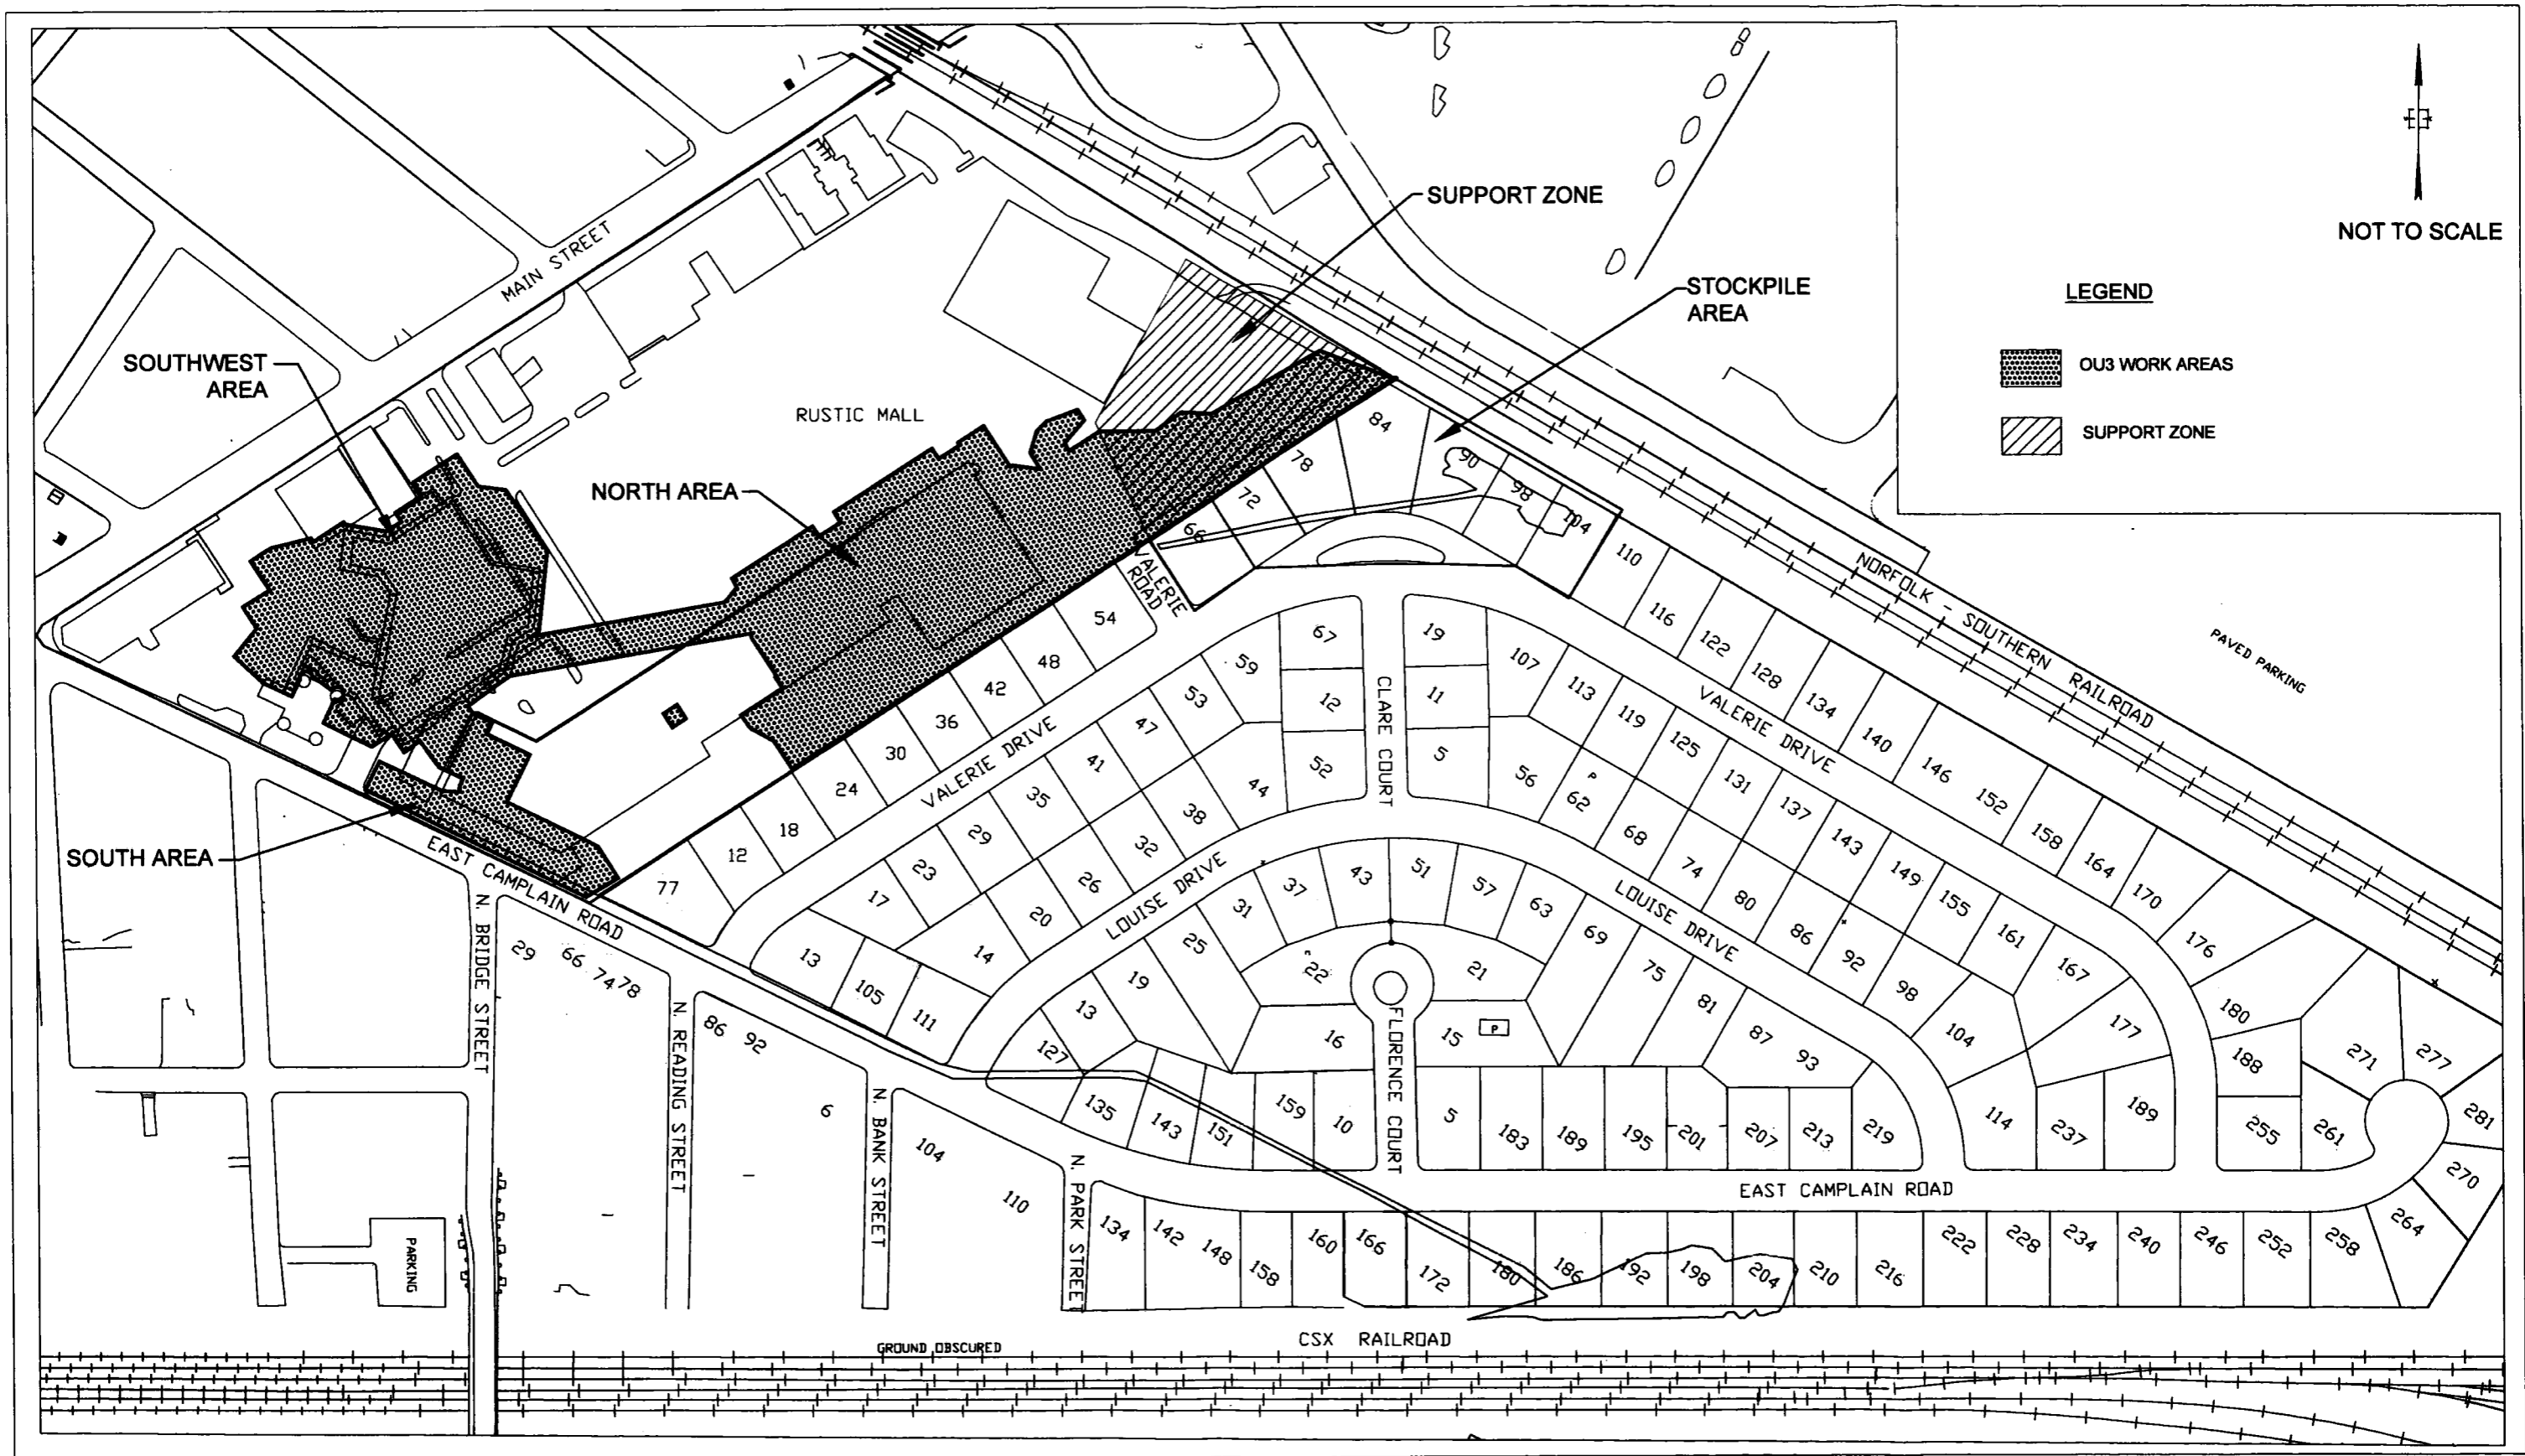
FIGURE 1-1
GENERAL SITE OVERVIEW
OU3-RUSTIC MALL

Two lagoons and associated canals that serviced the facility were located in the north central and southeast sections of the site. The lagoons and canals are believed to have contained liquid waste generated from the creosote wood preservation operation. The lagoon in the north central section of the site and its associated canal are referred to as Lagoon A and Canal A, respectively. The lagoon and canal in the south portion of the site are referred to as Lagoon B and Canal B, respectively. Additionally, several impoundments, standing liquid areas, and stained areas were identified northeast of the main treatment facility. Figure 1-1 shows the overall site layout.
